Impact of Gully Erosion on the Residents of Kontagora, Niger State

¹Iwalaiye Elizabeth Mayokun & ²Arowolo Jacob Gbemiga

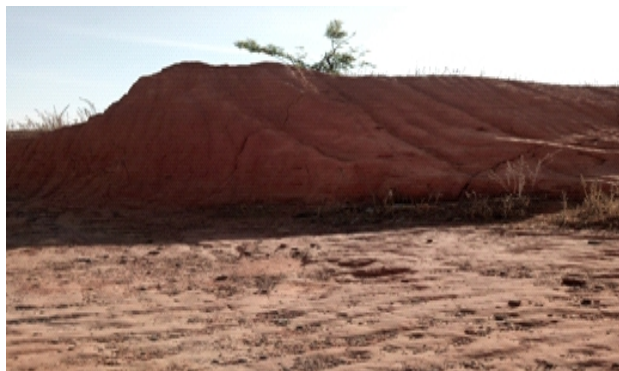
1. Behind Abuja Electricity Distribution Corporation AEDC along Federal College of Education (FCE) road, in Kontagora: This is site A, in figure 2, it is selected because the site is used for molding of mud blocks and sand excavation during the rainy season. It is a rock formed as a result of accumulation of sand and stones. The red soil of the rock is clayey and very good for molding of blocks this is why human activities of this kind takes place there. During the rainy season the exposed soil is vulnerable to erosion and being excavated for sand filling eroded areas in the community. Human factor is the major cause.

Figure 2: A Mud block industry behind AEDC (Site A)

Human activities of mud block making has affected the area thereby making it vulnerable to erosion, the area has a wide pit as a result of excavation and digging out of soil for construction purposes. An observation behind old market also shows that the area is influence by human activities of modern block making and irrigation farming. These Anthropogenic factors combine to weakened soils to produce severe gullies. The soils are hence loose and slumps under high intensive rainfall that renders them easily detachable. Some of the soils have the tendency to slake and form seals under such intense rainstorms thereby resulting in considerable runoff and soil erosion. The soil erodibility factor has since been recognized as a contributing factor to soil erosion hazard.

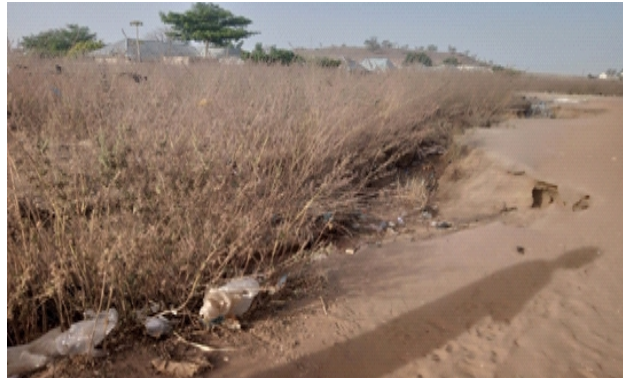
Figure 3: A damaged road beside UBE primary school, old Kwangwara (Site B)

2. Along Universal Basic Education (UBE) primary school at old kwangwara: This is site B, it is selected because the area is along a minor road surrounded by houses. The area is seen in figure 3; it is known to be vulnerable to erosion due to the local geologic setting, the permeability, porosity, cohesion and hydrodynamic events in the area. The gully erosion menace is thriving as a result of absence of well-coordinated control measures and inadequate and urgent attention it deserves.

From the above table, it is observed that site C beside FCEK fence has the longest length 100m, it is observed that the length extended to a long distance and collapsed a minor road which is now abandoned for only foot parts and used for waste land where cabbages, excreta and refuse are littered. More so, foundations of buildings along this part are collapsed. Site A has the deepest depth of 10m. This is as a result of continuous excavation of mud soil for block making and for sand filling over a long period of time which has finally led to a gully. In essence it has the highest height of 6m this shows how high the hill is. The gully in site B of old Kwangwara UBE primary school road has a peculiarity because the gully is formed on the road where humans and cars pass.

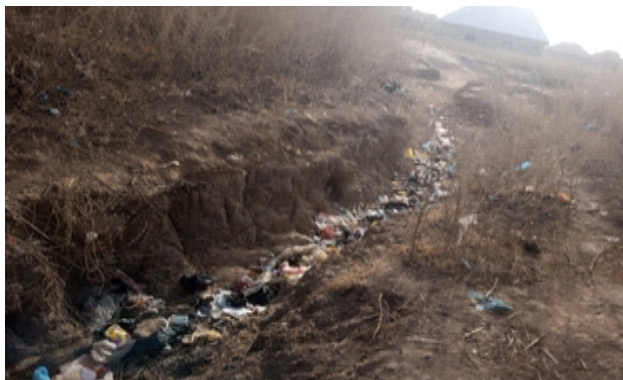
Figure 4: A damaged road beside FCE Kontagora fence (Site C)

3. Beside Federal College of Education (FCE) fence: This is site C, as observed in figure 4, it is within clustered settlement beside FCE fence, and it is occupied by residents of staff and students of the college. Due to the porosity of the soil geology run-off played significant role in gulling, runoff at vulnerable region where there is poor drainage shows elevation changes within valley slopes which is observed in this site.

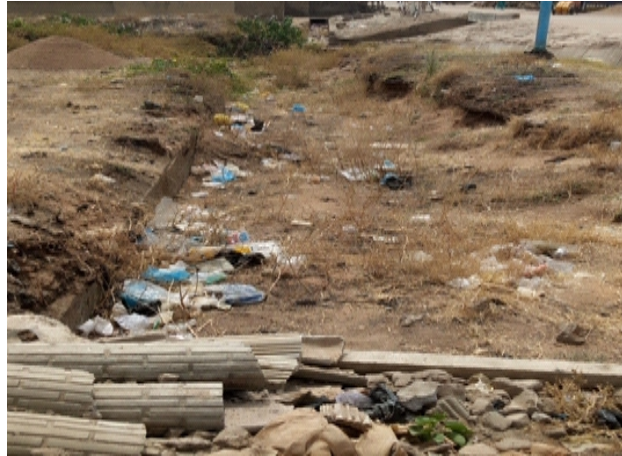
Figure 5: A modern block making industry with gully erosion behind old market (Site D)

4. Behind Old Market: This is site D, It is selected because it is within clustered settlement dominated by the indigenes of Kontagora behind old market as seen in figure 5. The areas has poor drainage pattern and it is also characterized by human activities such as modern block making and irrigation farming. Refuse are also dumped and cabbages litter around known as 'bolla' in Hausa language.

By observation, it is concluded that the gully is a result of natural and human cause. The soil type is very porous, and it lacks drainage pattern. There is a threat on the road presently because it could collapse at any time if control measures are not taken. The peculiarity in site D is that it is found beside a bridge, irrigation farm and modern block industry where the soil is threatened by all these human activities, and because of the geology of the soil, the soil is easily loosened and eroded.
