Assessing the Socio-Economic Impact of Gully Erosion in Chikun Local Government Area, Kaduna State, Nigeria

¹Aliyu Hassan Ibrahim, ²Nura Alhaji Yaro & ³Abiodun Olufemi Adebola

Abstract

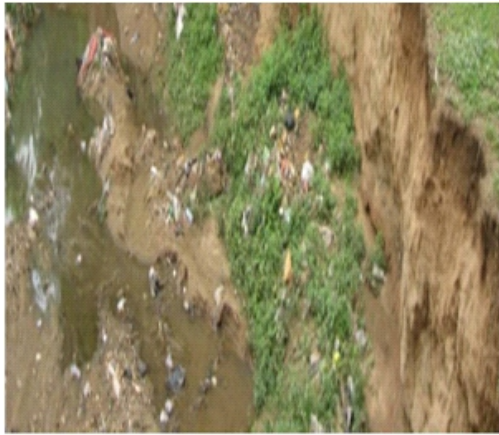
Plate 1: High Wall of Erosion Complex
Source: Field Work, 2016

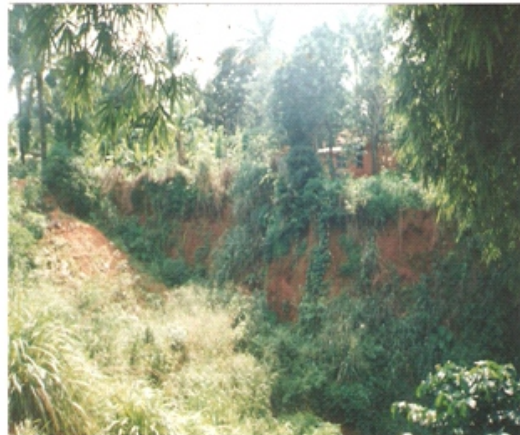
Plate 2: A House Threatened by Gully Erosion in Chikun LGA.
